EXHIBIT H – EQUIPMENT SPEC SHEETS

MONTGOMERY - ELLINGER
EAST ILLINOIS ROUTE 16,
LITCHFIELD, ILLINOIS 62056
LAT/LONG: 39.175908, -89.601318

Results from the offsite wetland analysis identified several areas with potential wetland characteristics, warranting an onsite investigation. **A Level 2 onsite delineation, performed by EOR on June 7, 2024, found that the Study Area contained three wetlands, two of which likely drain to the West Fork Shoal Creek and be considered regulated Waters of the United States (Section 4.3.3).**

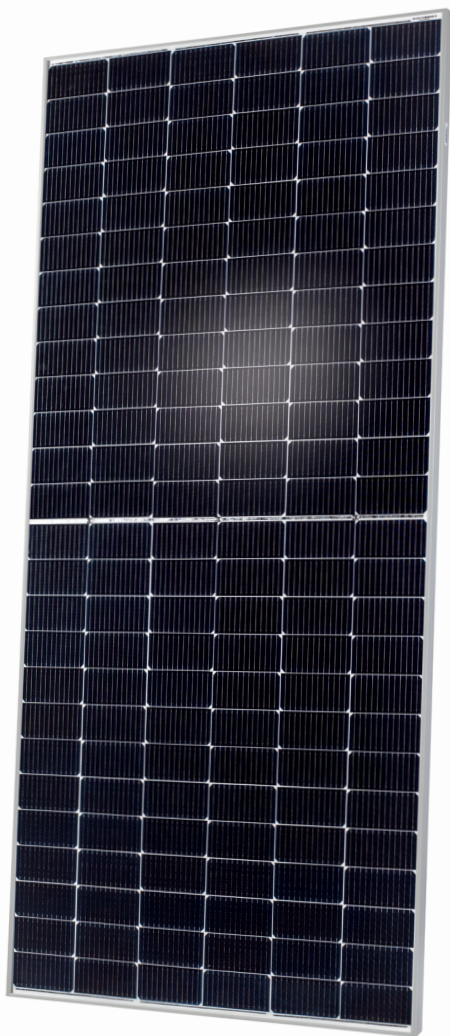
MODEL Q.PEAK DUO XL-G11S.3/BFG

Bifacial energy yield gain of up to 21%

Bifacial Q.ANTUM solar cells make efficient use of light shining on the module rear-side for radically improved LCOE.

Double glass module design enables extended lifetime with 12-year product warranty and improved 30-year performance warranty¹.

High-tech aluminum alloy frame protects from damage, enables use of a wide range of mounting structures and is certified regarding IEC for high snow (5400 Pa) and wind loads (2400 Pa).

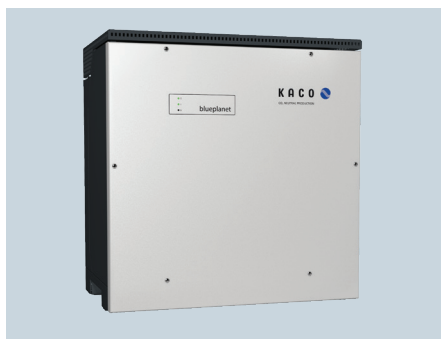
Transformerless, three-phase string inverter

The trendsetter among inverters

- Optimized for solar power plants with 1500 volt modules
- Extensive grid management functions
- Special properties for extreme climatic conditions
- Farsighted technical features for future requirements
- Lean commissioning and maintenance via remote services

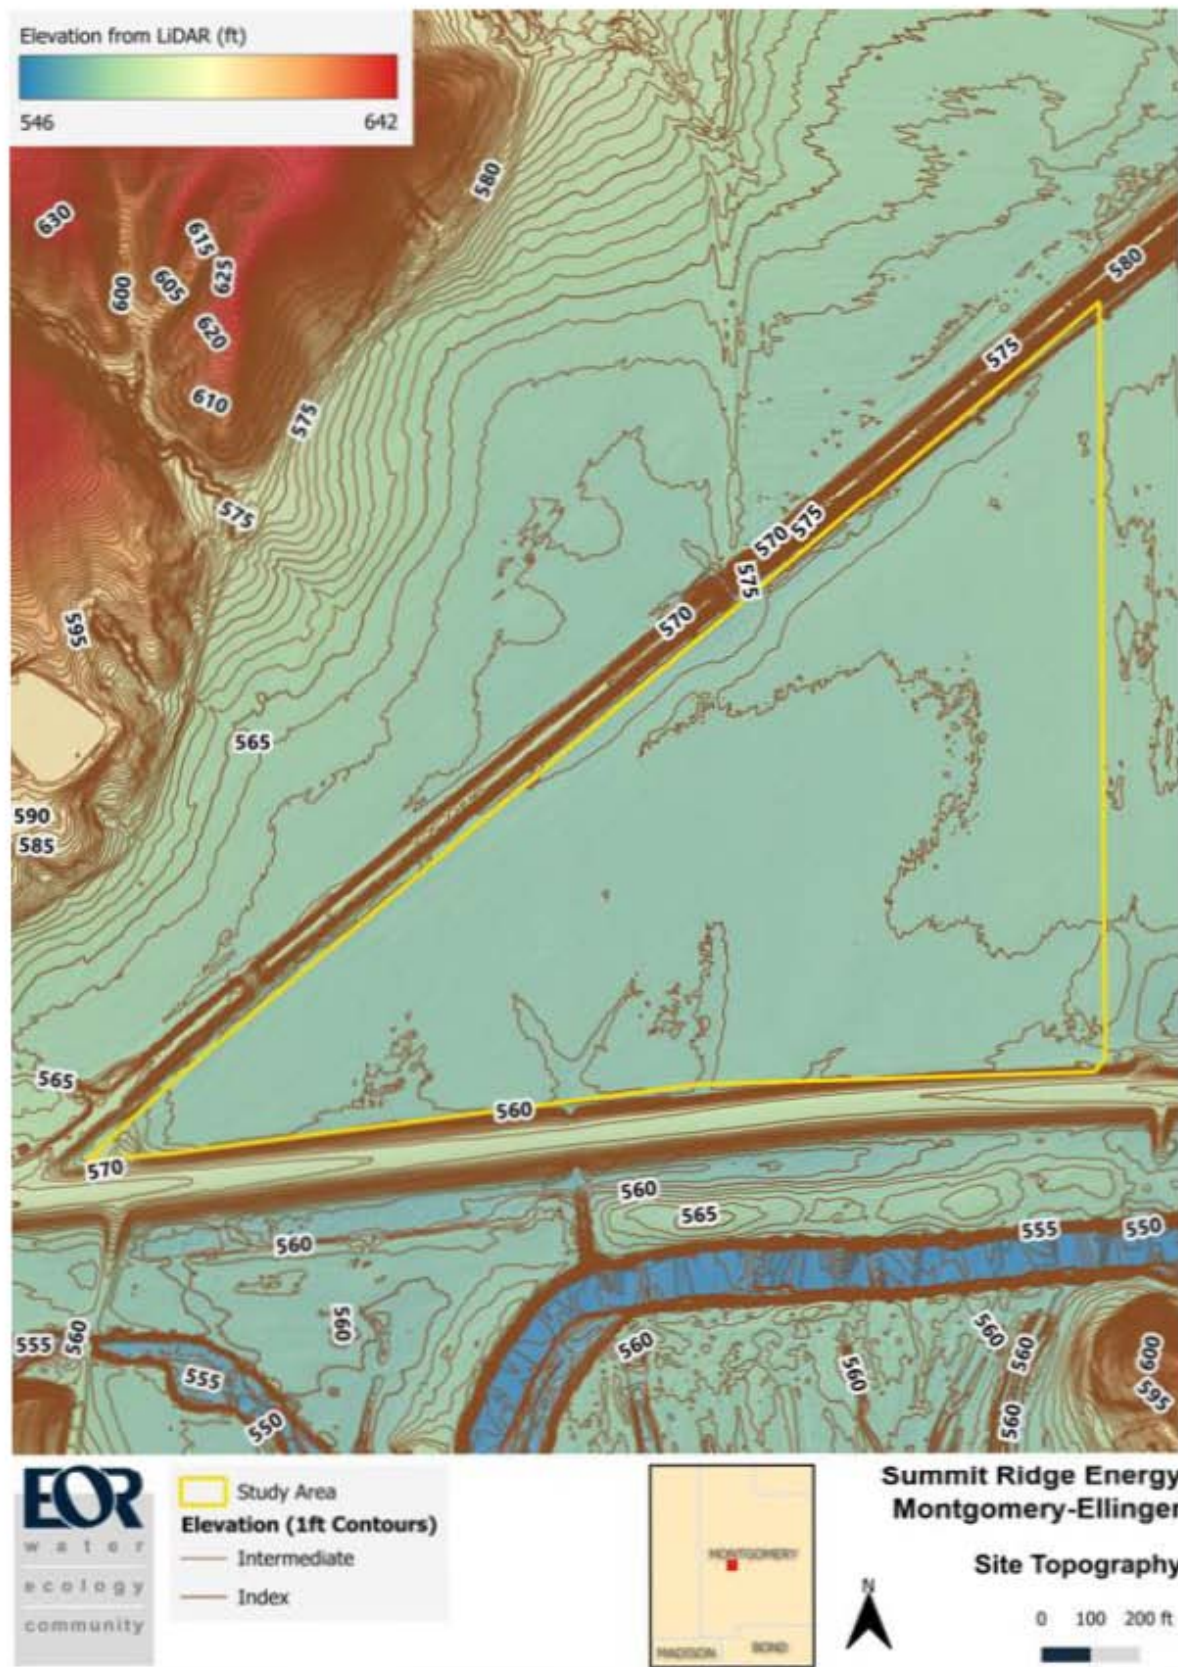
Figure 3. Topography is mostly flat with overland drainage generally directed toward the southwest portion of the Study Area.
